**Evaluation of the structural capacity of historical  
constructions**

## **Evaluation of the structural capacity of historical constructions**

Dissertação apresentada à Universidade de Aveiro para cumprimento dos requisitos necessários à obtenção do grau de Mestre em Engenharia Civil, realizada sob a orientação científica do Professor Doutor Romeu da Silva Vicente, Professor Associado do Departamento de Engenharia Civil da Universidade de Aveiro e co-orientação científica do Professor Doutor Pere Roca Fabregat, Professor Catedrático do Departamento de Engenharia da Construção da Universidade Politécnica da Catalunha e do Professor Doutor Hugo Filipe Pinheiro Rodrigues, Professor Adjunto do Departamento de Engenharia Civil do Instituto Politécnico de Leiria.

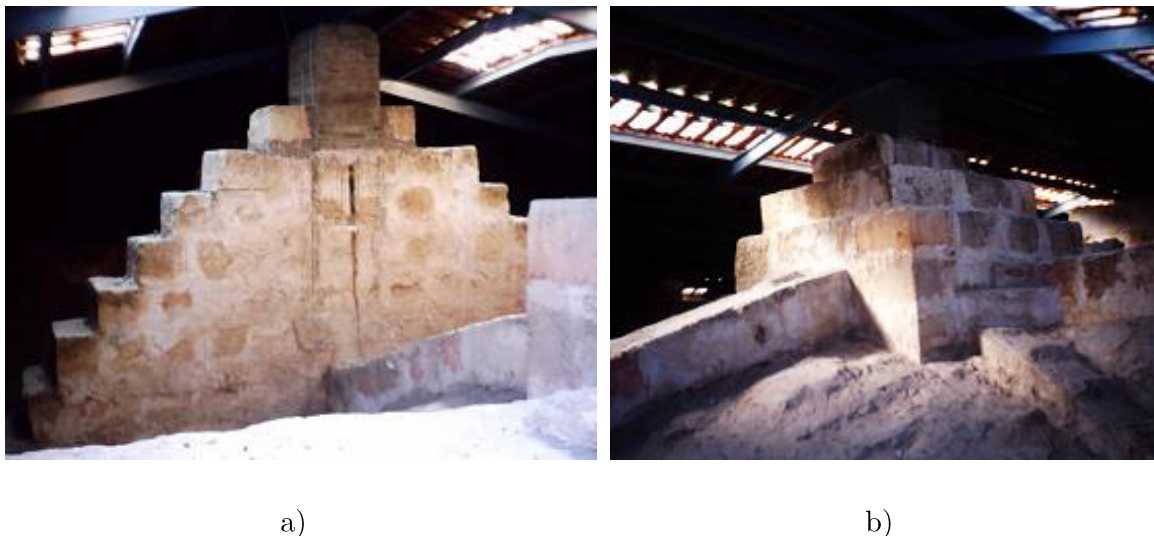
**Figure 4.7** – Additional overloads of Mallorca cathedral: a) over the transversal arches key and b) over the vaults keys.

Another detail is the presence of some necessary overloads in the shape of triangular masonry masses to guarantee the cathedral stability, on the transversal arches (see Figure 4.7 a) a symmetrical triangular wall reaching its maximum depth at the key of the arch and on the keys of the vaults, the overload occurs as a pyramid of square bases (see Figure 4.7 b), these overloads are essential due to the fact that the vaults are not filled with rubble masonry but only with a light structure composed of slender stone wallets and slabs (Mohamed 2015).

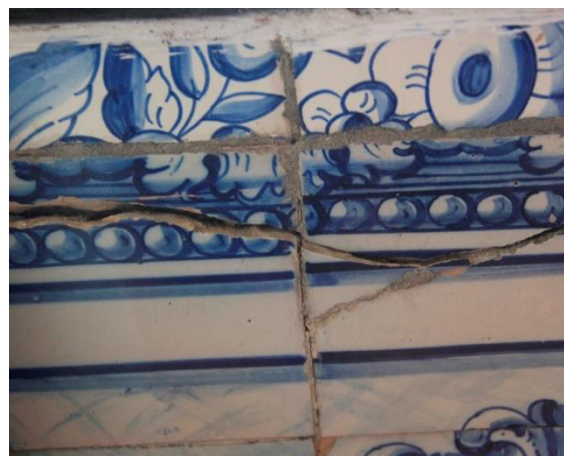
**Figure 5.12** – Cracking in the tiles in the lower part of the wall below the window.

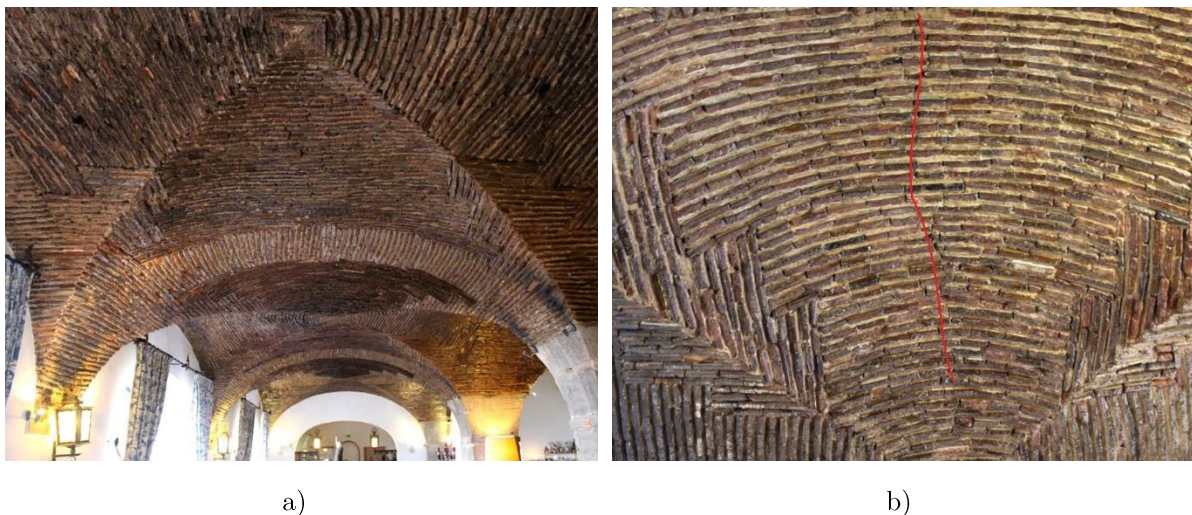
**Figure 5.15** – Longitudinal cracking inside the building: a) continuous longitudinal alignment b) cracking detail of the masonry vault.

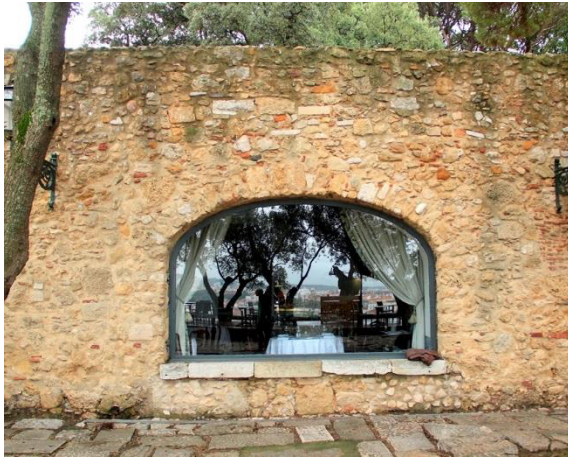
**Figure 5.16** – Linearity break along the spans in the west façade.

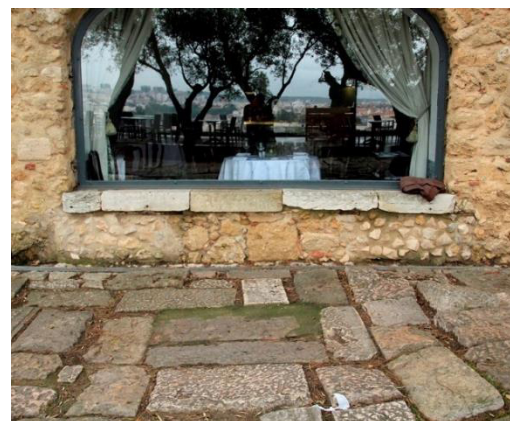
**Figure 5.19** – Irregular stone pavement outside the building.

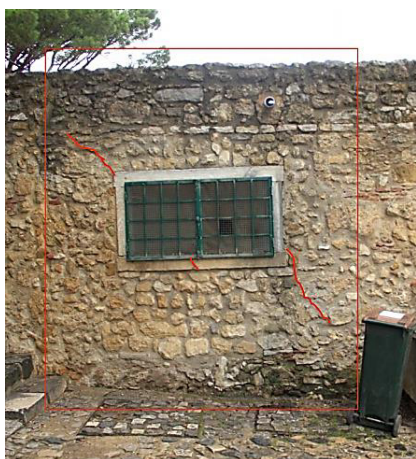
**Figure 5.20** – Cracking in the east façade.

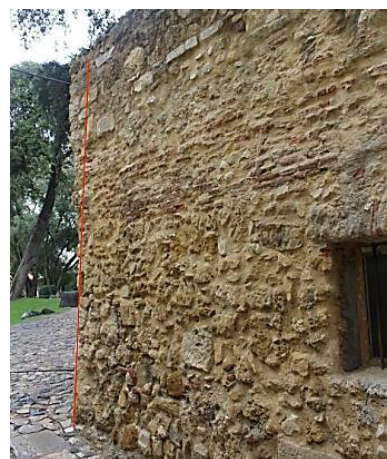
**Figure 5.21** – North façade out-of-plumb, visible on the north and east direction.

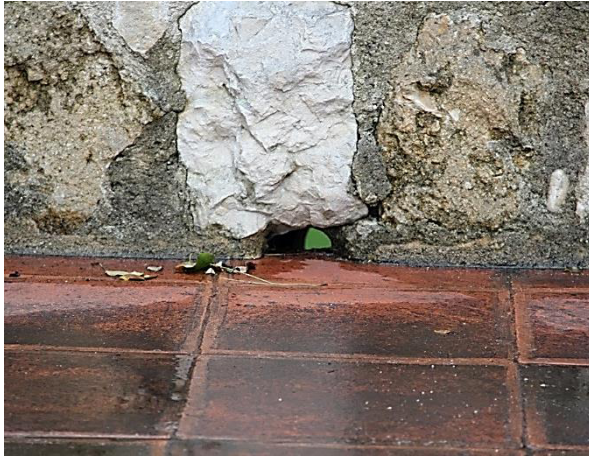
**Figure 5.22** – Inefficient rainwater drainage and the waterproofing system.

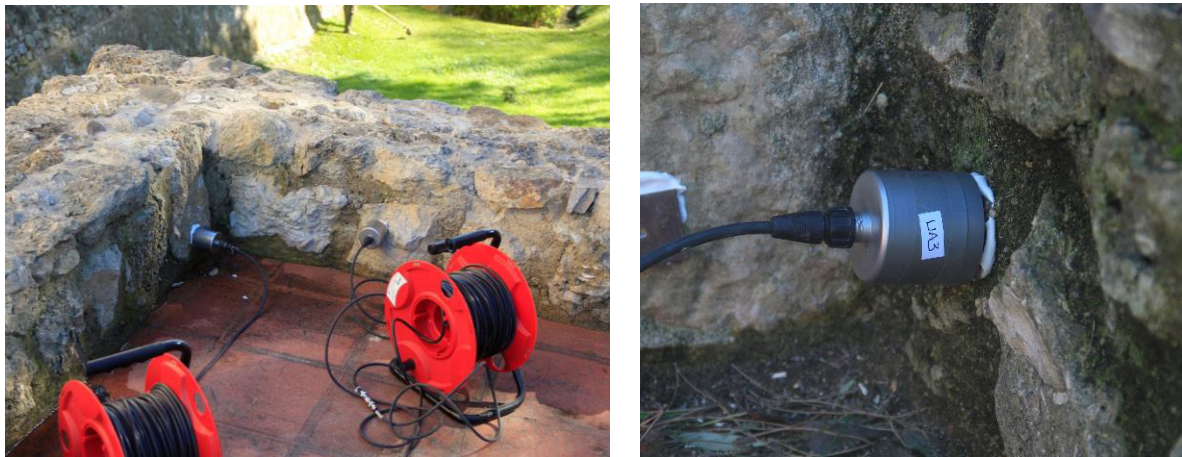
**Figure 5.29** – System and piezoelectric unidirectional accelerometers.

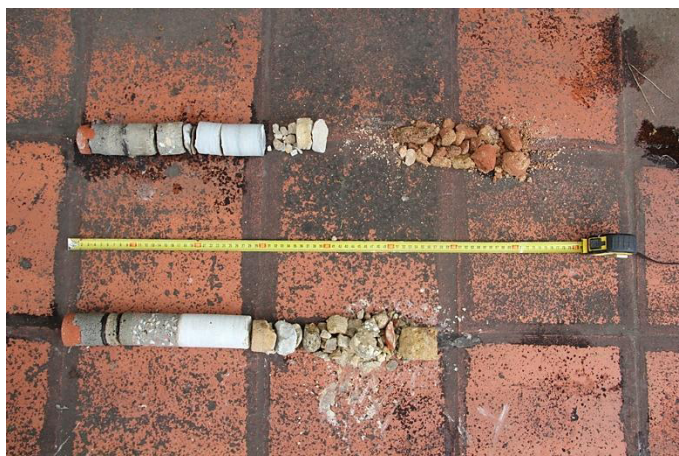
**Figure 5.38** – The two cores samples extracted, representing the layers.

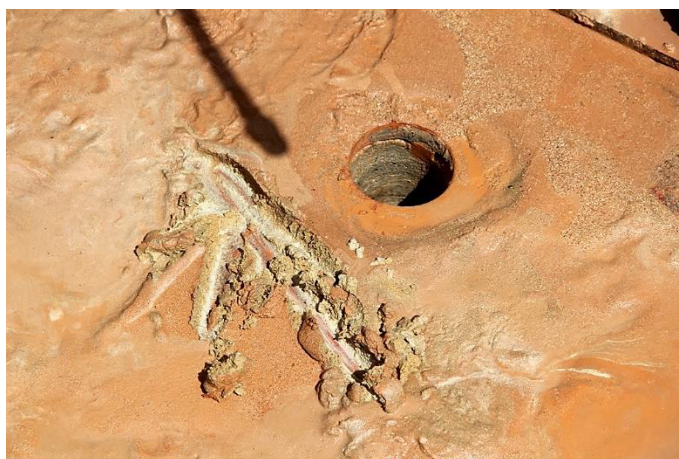
**Figure 5.39** – Filling layer of sand leached during the extraction process.

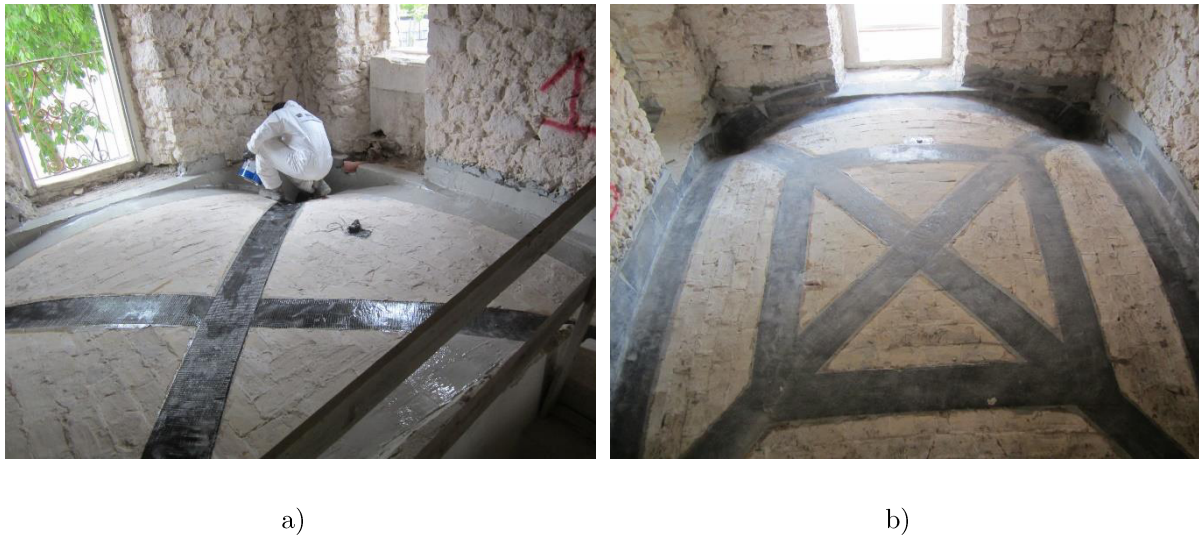
**Figure 5.92** - FRP retrofitting strategy in Via Roma San Pio, L'Aquila: a) placement of the FRP strips and b) final result (SismyGroup 2016).
